BLACKSTONE RIVER BASIN
WORCESTER, MASSACHUSETTS

LEESVILLE POND DAM
MA 00141

**PHASE I INSPECTION REPORT
NATIONAL DAM INSPECTION PROGRAM**

AUGUST, 1978

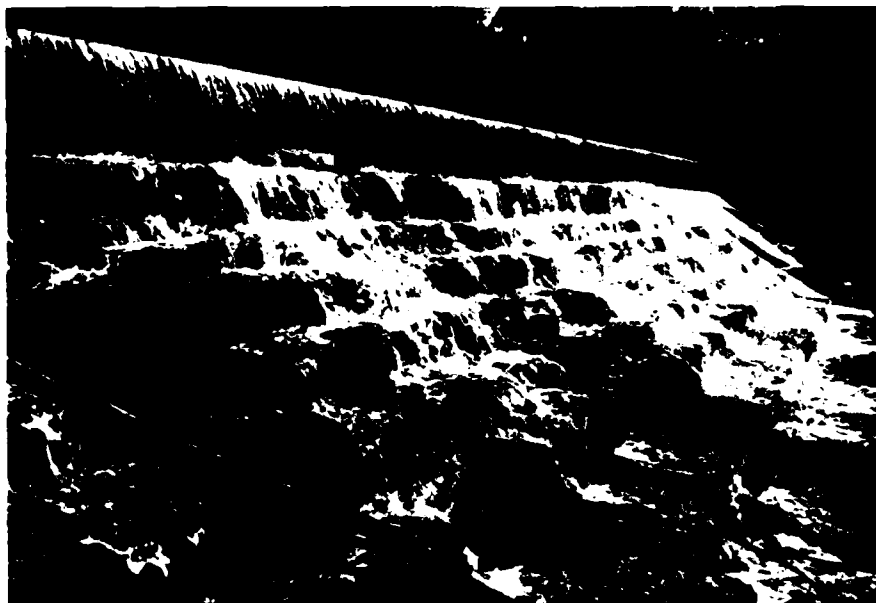
- c. Appurtenant Structures. The concrete and stonework on the spillway are in fair to good condition. Holes for flashboard pins are still visible on the weir and there is minor spalling and erosion on the training walls. The concrete face south of the stepped section is in good condition. Seepage is evident at the toe of the north spillway abutment (see Figure B-1). A tree is growing at that location and the seepage appears to be following the roots.

NO. 1 VIEW OF SPILLWAY CASCADE FROM NORTH ABUTMENT
